West Bloomington Plan Area and Building Conditions Report 2008

CITY OF BLOOMINGTON WEST BLOOMINGTON NEIGHBORHOOD PLAN AREA AND BUILDING CONDITIONS REPORT

Prepared by
Department of Planning and Code Enforcement
Code Enforcement Division
115 East Washington Street
Bloomington, Illinois 61701

September, 2008

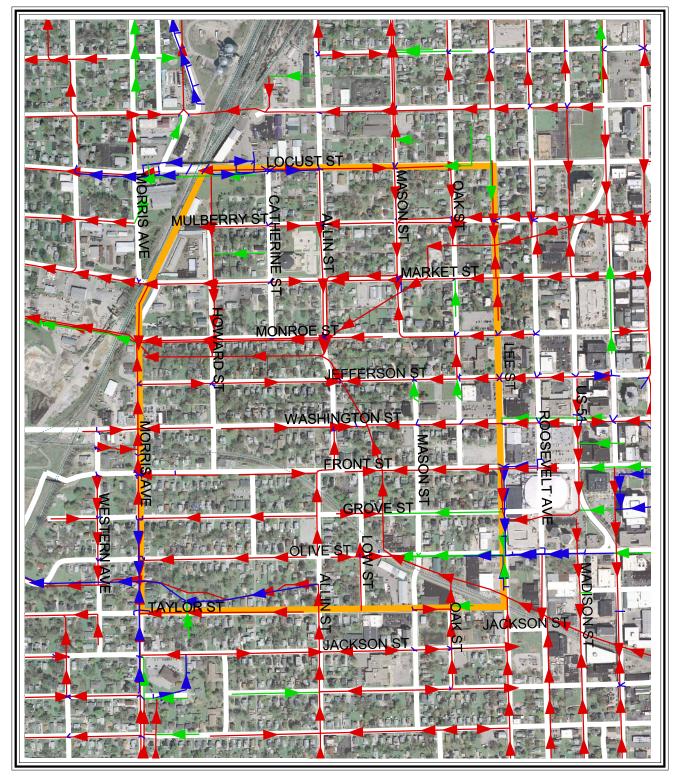
Figure 12 - Existing Sewer Infrastructure

A review of the sewer infrastructure of the West Bloomington Neighborhood Plan area indicates an area with an extensive network of a combination storm and sewage system. A combined sewer system was designed to transport both storm water runoff and sewage in the same pipe. This combination is seen as inadequate according to today's standards. (Figure 12) Often, combined sewers can not handle the volume of runoff, resulting in overflows, quite often into basements, and can cause water pollution problems in nearby water bodies.

Unfortunately, the cost of replacement of these types of systems with separate storm and sewage systems is too exorbitant for most localities. A reasonable proposal to help deflect sewage backup into basements is the installation of a sewer ejection system. The City of Bloomington has been offering an overhead sewer program for identified single-family owner-occupied structures. However, it may be necessary to extend the program to include other multi-family structures to improve the overall sewage system for this area.

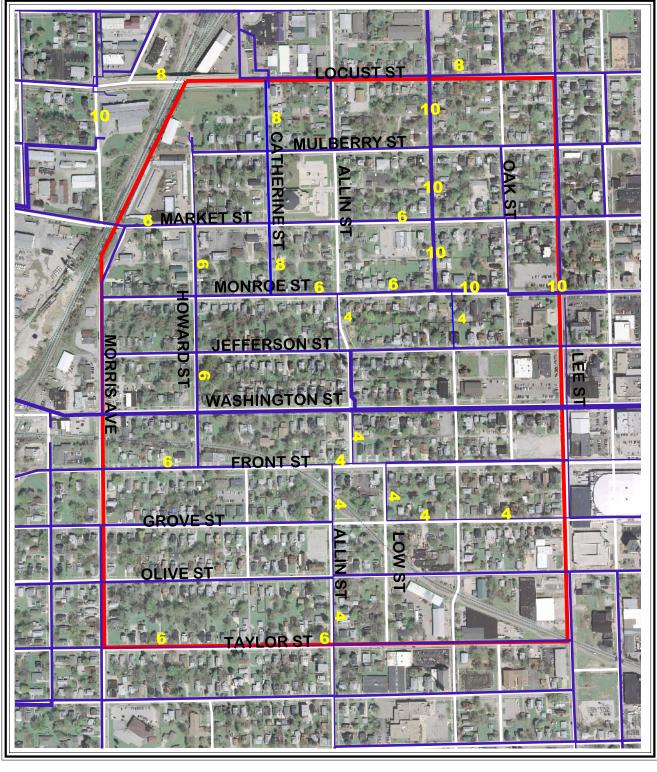
Figure 13 - Existing Water Infrastructure

Similar to the sewer infrastructure, the existing water supply system within the West Bloomington Neighborhood Plan area also proves to be inadequate for today's standards (Figure 13.) Outdated water delivery systems create a variety of problems such as high energy demands and lack of water pressure.

- a) Reinforcing existing water mains with new larger diameter mains.
- b) Starting a program to replace 5/8" lead water services. Included would be a program to provide dedicated water services to those houses presently not so served.
- c) Starting a program to replace obsolete fire hydrants.

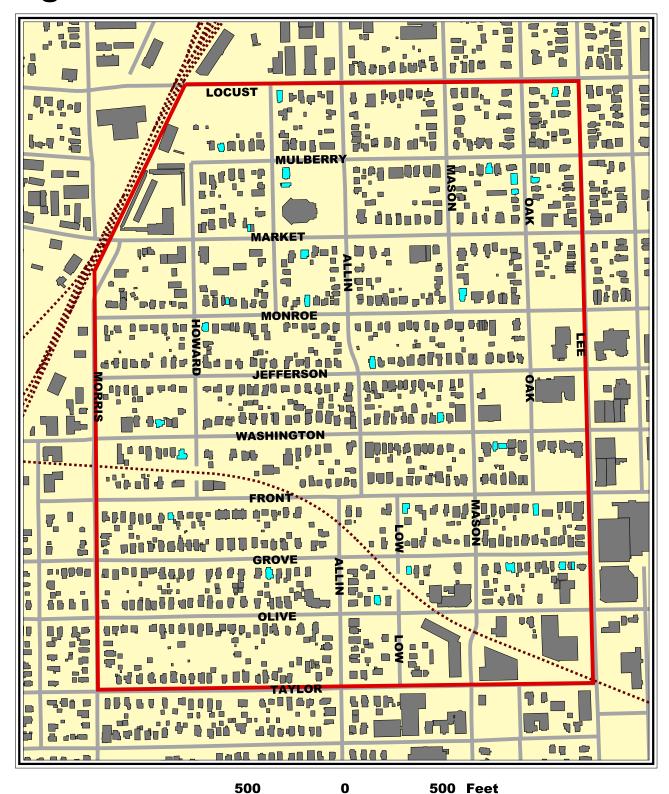
Figure 14 - Known 2 on 1 Water Services

A sample of the area water services indicate that over 20% of the houses are not served by a dedicated (one service per house) water service. The remaining water services, primarily 5/8" lead do not approach modern standards. Known 2 on 1 water services are indicated on Figure 14. More often than not, property owners are unaware their water service is not directly connected to the water main as a single service until it breaks. Replacing these types of services helps to eliminate future repair problems and allows the Water Department to address any water bill non-payment issues directly with a single property owner.

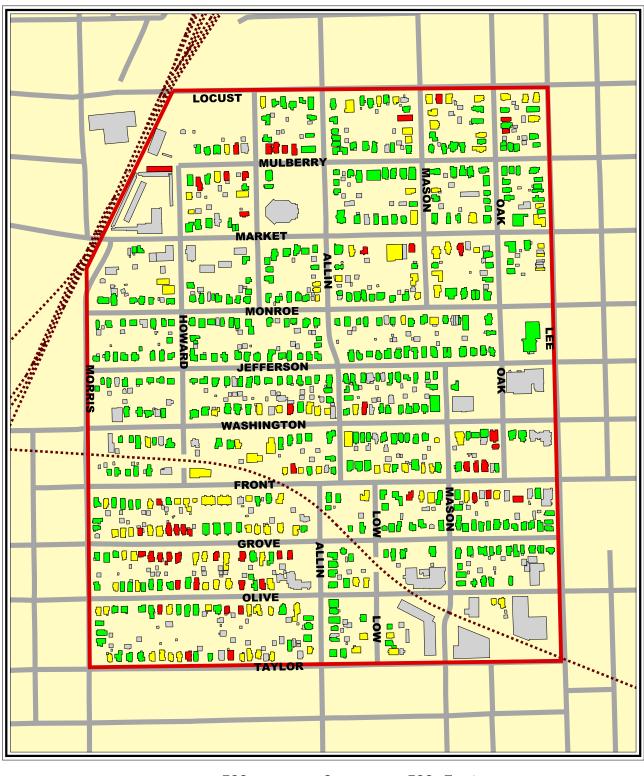
Figure 15 - Existing Sidewalk Conditions

From viewing Figure 15, it appears that any priority area for comprehensive sidewalk replacement should be in the southwest portion of the West Bloomington Neighborhood Plan area (i.e. Front Street, Grove Street, Olive Street and Taylor Street between Allin Street and Morris Avenue.)

An individual property owner can initiate sidewalk replacement through the 50/50 Sidewalk Replacement Program. However, it may be well advised to include sidewalk replacement costs at the same time as any replacement of existing, deteriorated curb and gutter. Figure 16 depicts those curb and gutters in the West Bloomington Neighborhood Plan area which are either deteriorated or lacking. During the City's 2008-09 fiscal year four projects to replace either deteriorated curb, gutter and/or sidewalk were funded with Community Development Block Grant (CDBG) moneys. They were: Sidewalks on both sides of the 500 and 600 block of West Grove Street; curb/gutter and some sidewalks on North Oak Street from Monroe to Mulberry, on Allin Street from Market to Locust, and on Market Street from Allin to Howard.

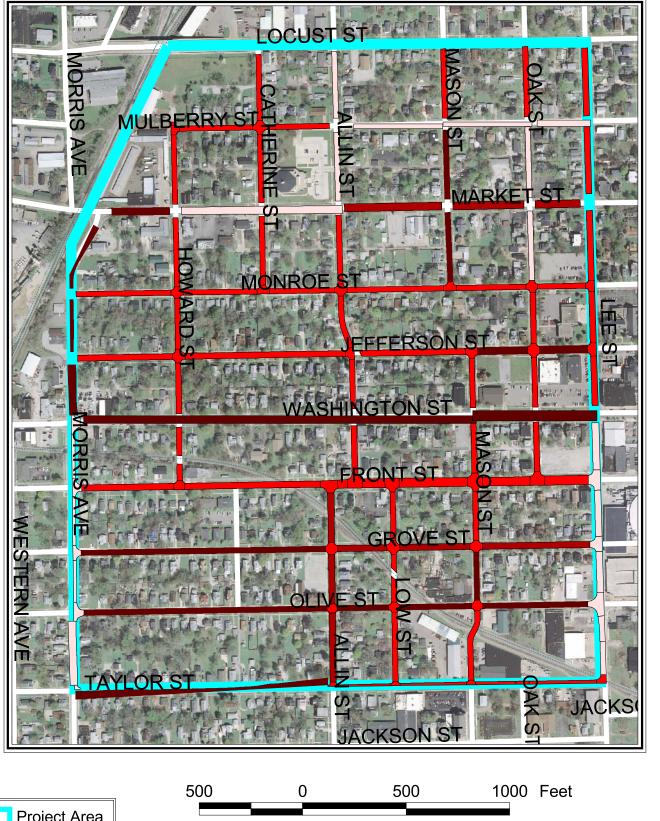
Figure 16 - Existing Curb & Gutter Conditions

Priority areas in need of curb and gutter replacement are: Mason Street from Monroe to Mulberry, Jefferson Street from Mason to Lee, West Grove Street from Allin to Morris Avenue and Olive Street from Lee to Morris Avenue, Morris Avenue from Washington Street to Market Street.

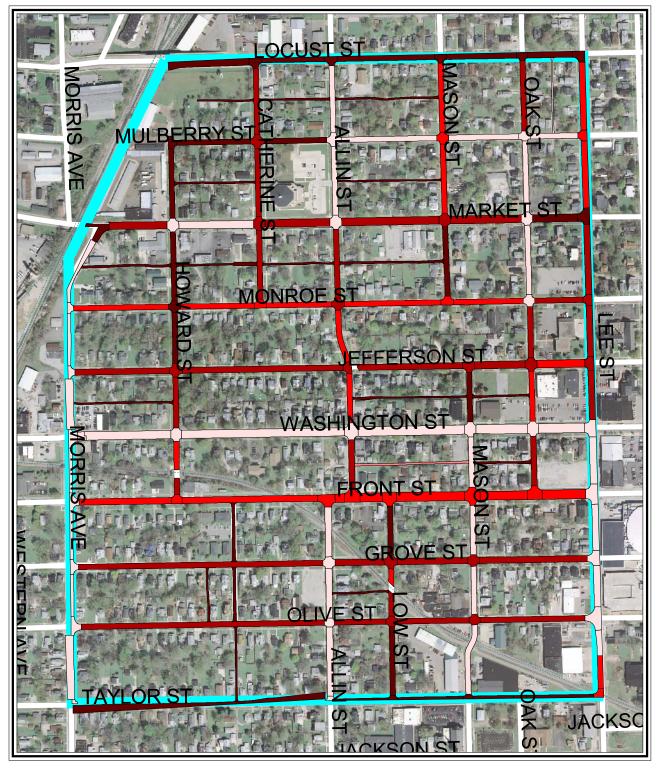
Figure 17 - Existing Pavement Conditions

Going hand in hand with curb and gutter replacement is the potential need for street resurfacing. Figure 16 indicates the pavement condition in the plan area. Approximately one-third of the area appears to be rated fair to poor conditions. Scheduling for street resurfacing should be in coordination with the timing of curb and gutter, and even sidewalk replacement.

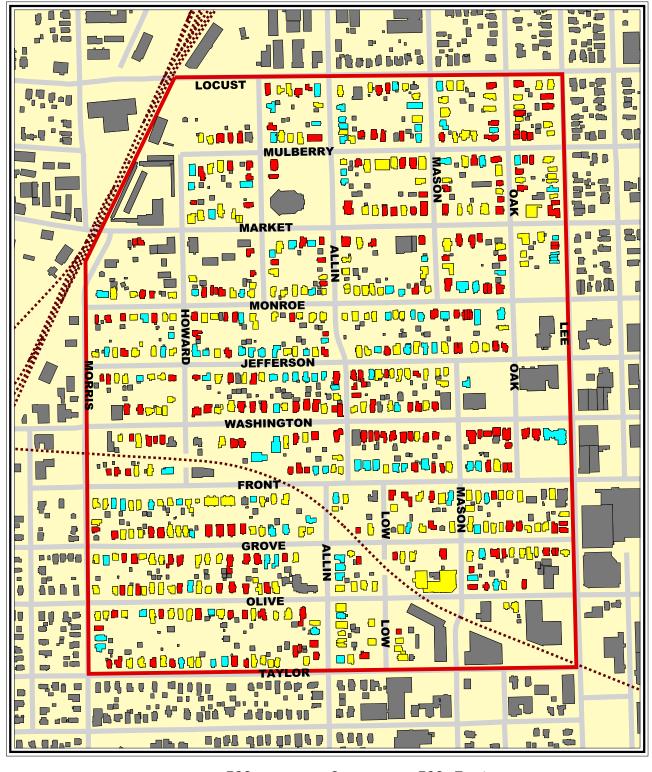
Figure 19 - Exterior Residential Building Conditions

Figure 19 displays all the exterior residential building conditions within the plan area, while Figure 20 indicates exterior building conditions of the single family dwellings while Figure 21 indicates exterior building conditions for the rental properties in the area. The building ranks are represented by 3 different colors that are displayed within the footprint of the buildings. Buildings with a ranking of 1 to 2 are assigned the color blue and are considered to be in "sound" condition; generally consisting of new, like new, or remodeled buildings. The ranking of 2-3 is displayed in yellow; representing buildings with conditions "minor" in nature; generally consist of buildings requiring minor repair or repair to components that are not essential to the structural integrity of the building. The ranking of 3-6 is assigned the color red; representing buildings with "major or critical" building conditions; consisting of buildings requiring one or both of the

following: major repairs to several minor building components (or) repair or replacement of a critical component vital to the structural integrity of the building.

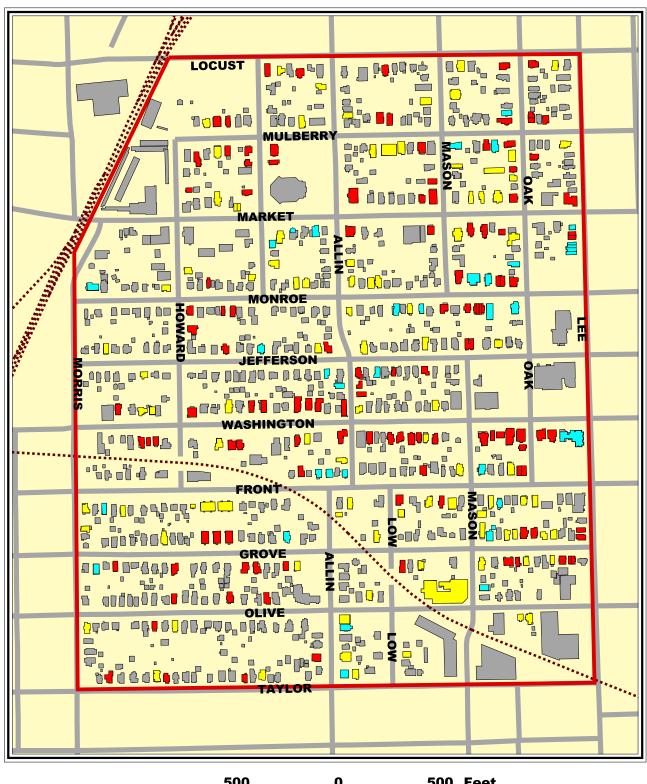
Figure 21 - Exterior Rental Building Conditions

There were a total of 254 rental buildings ranked (exterior only); 35 (14%) are labeled "sound", 90 (35%) are labeled "minor", and 129 (51%) are labeled "major/critical". Although the average ranking of rental buildings overall is 2.93, still within the "sound and minor" ranking scale, it is important to note that half of the rental buildings were labeled "major/critical" based on exterior building conditions only. (See Figure 21.)
