**AGENDA
HISTORIC PRESERVATION
REGULAR MEETING
CITY HALL COUNCIL CHAMBERS
109 EAST OLIVE STREET; BLOOMINGTON, IL 61701
THURSDAY, MARCH 21, 2019, at 5:00 P.M.**

CASE NO:	TYPE:	ADDRESS	SUBJECT:	REPORT BY:
BHP-02-19	Certificate of Appropriateness	809 N McLean	Chimney and roof repair and replacement	Izzy Rivera
BHP-03-19	Funk Grant	809 N McLean	Chimney and roof repair and replacement	Izzy Rivera

CITY OF BLOOMINGTON
REPORT FOR THE HISTORIC PRESERVATION COMMISSION
MARCH 21, 2019

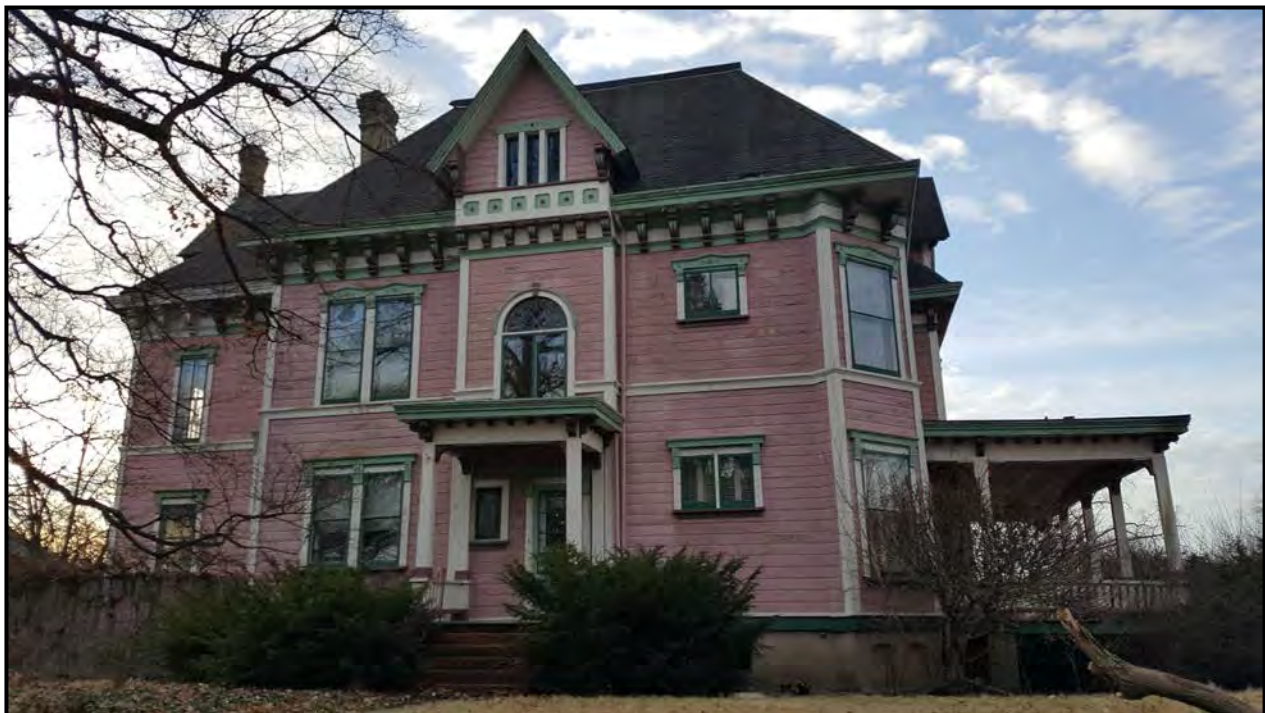
Picture of Subject Property

REQUEST:	A Certificate of Appropriateness and a Funk Grant for \$5,000.00 to repair and replace the chimney and roof at 809 N. McLean Street, Gothic, Romanesque and Late Victorian Influences, c. 1882 George Miller with alterations by Arthur L. Pillsbury in 1909. Franklin Square Historic District.
-----------------	--

The petitioner is requesting a Certificate of Appropriateness and a Funk Grant for \$5,000.00 to repair and replace the roof and the chimney. The work will consist of removing seven layers of roofing material and checking the roof deck to ensure it is structurally sound. The proposed

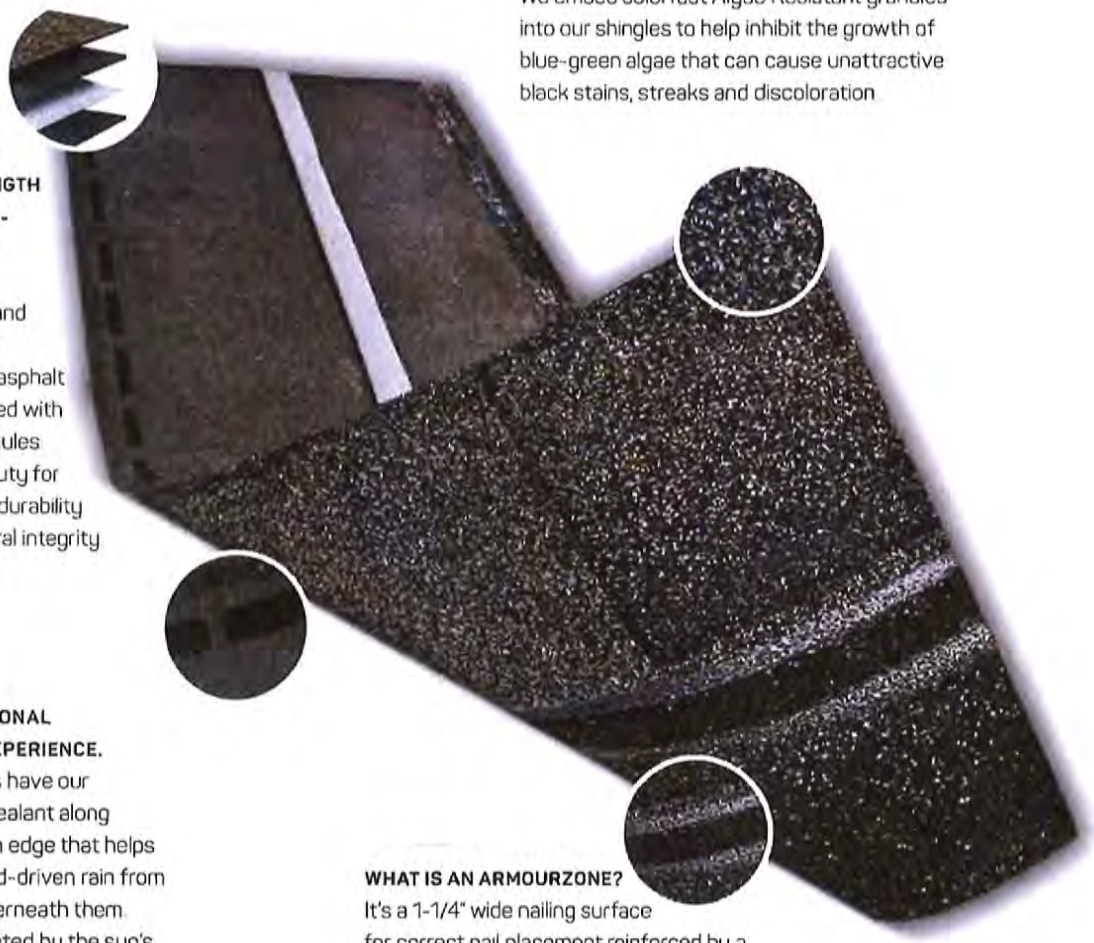
WHAT IS AN ARMOURZONE?

It's a 1-1/4" wide nailing surface for correct nail placement reinforced by a tear-resistant band that provides even more fastening strength over a wider surface area of the shingle. Nails applied in this area are optimally

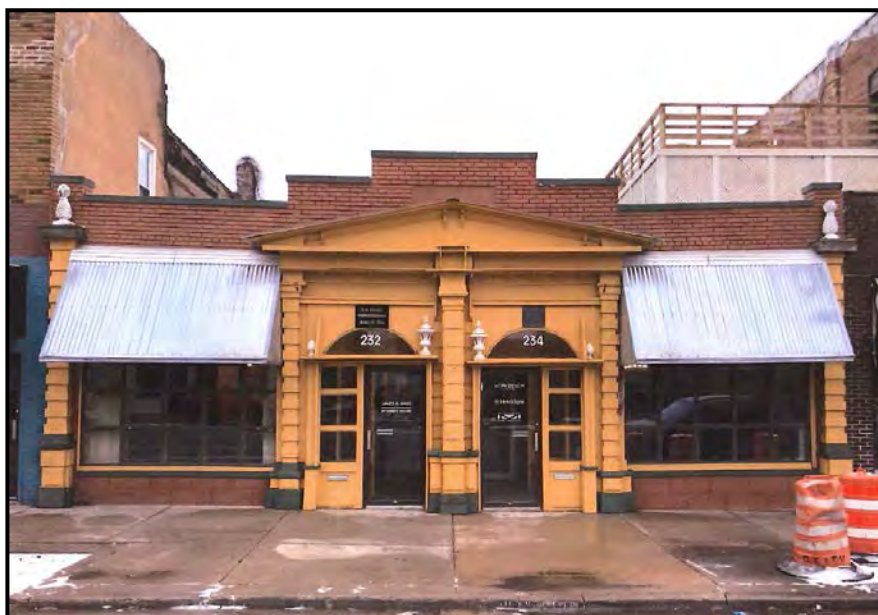
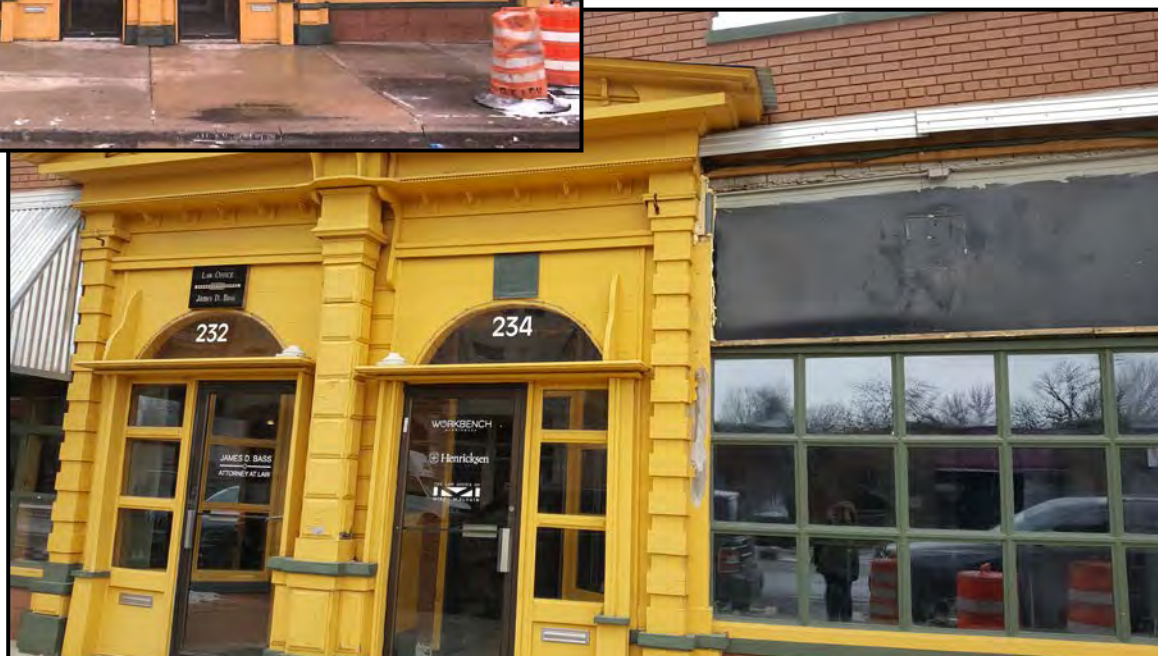
Picture of Subject Property

The site, 232/234 E. Front Street, is located in the Central Business Historic District and within the Rust Grant boundaries. The site is considered “contributing” which means it adds to the historic architectural qualities of the area. The site is considered to have been present during the period of significance or independently meets the National Register Criteria.¹ According to the National Register of Historic Places Inventory-Nomination Form from 1984, E. Front Street was a main road leading to and from the central business district. It also contained many key retail and professional buildings. After the fire in the early 1900’s, rebuilding was a large part of the construction. The scale of the buildings changed and were either larger than those of previous periods or small to fit in the gaps between earlier buildings. The subject property was built in 1927. The Fire Station (220-228 E Front Street) and the Horse Hospital (236 E Front Street) were built in 1902 and 1883 respectively. The smaller addition of 232/234 E Front Street, fits the pattern of development during the 1900’s after the fire².

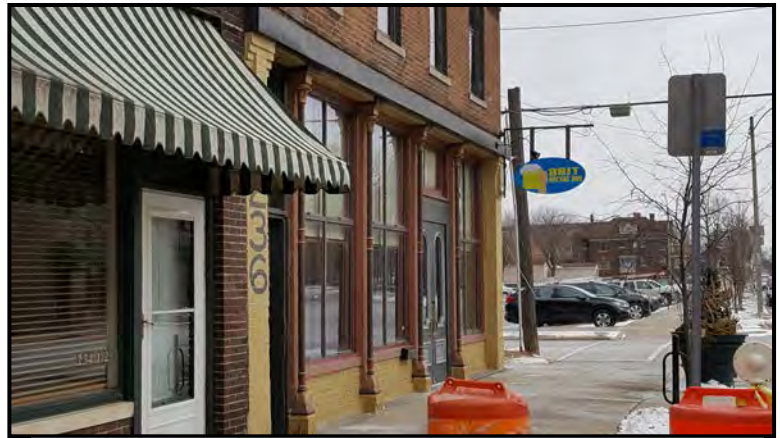
Large vertical storefront windows directly east of site

large portion of the top of the windows. At the time the wooden façade was installed, the windows and glass at the top portion of the storefront were covered. The faux Greek Revival wooden façade was part of a previous renovation. The petitioner is proposing to remove that façade and expose the original façade. Once the wooden façade is removed, the entrance will be setback further from the sidewalk as seen on the site plan included by the petitioner. The petitioner is also proposing to remove some walls at the entrance. The walls at the corner will be straightened out and will provide a better profile. (See demo plan included) The current window system will be removed and updated with an aluminum storefront system by Kawneer. The current windows are divided by simple 4x4 boards to create the illusion of multiple panes of glass. The updated system will bring back a more accurate visual of larger panes of glass. Similar to other storefronts on E. Front Street, the windows will be expanded further up, for a top to bottom window look, and will match the corridor.

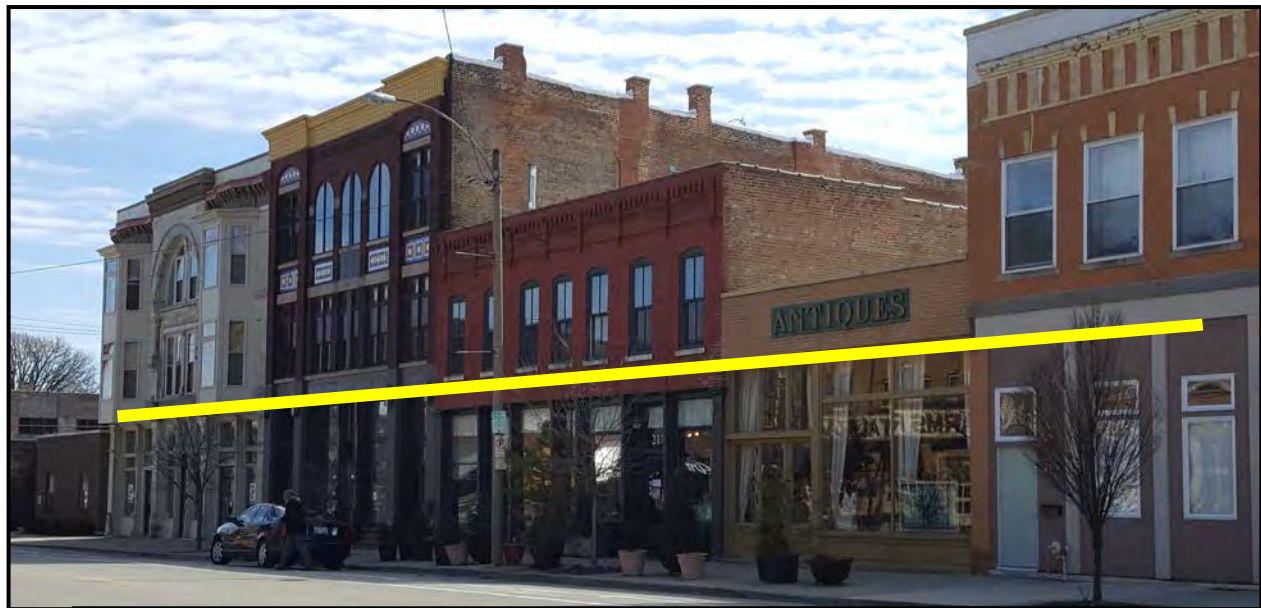
Store front with larger windows located across the street of 232 E Front St.

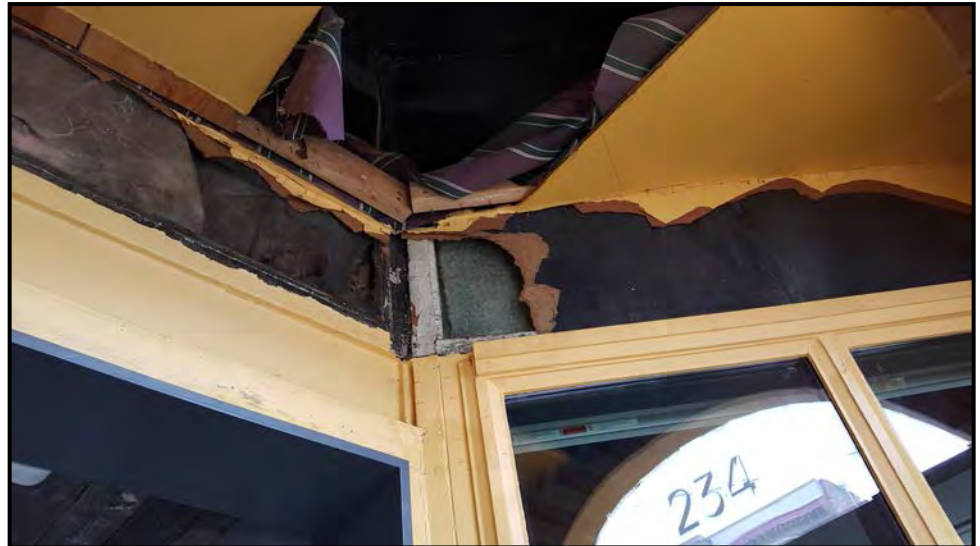
Inside the vestibule showing covered windows and glass

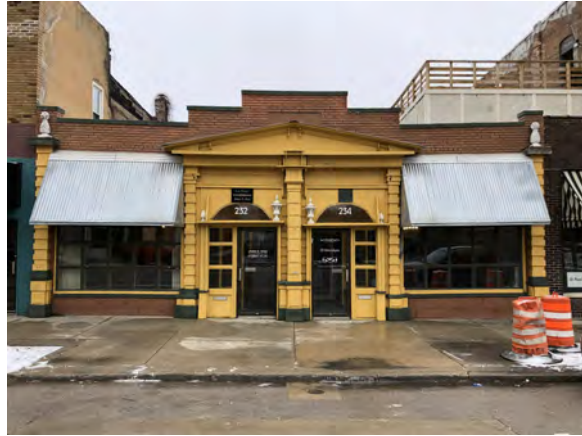
OVERALL VIEW OF EXISTING WOOD CLADDING FACADE WITH ORIGINAL FACE BRICK BEYOND.

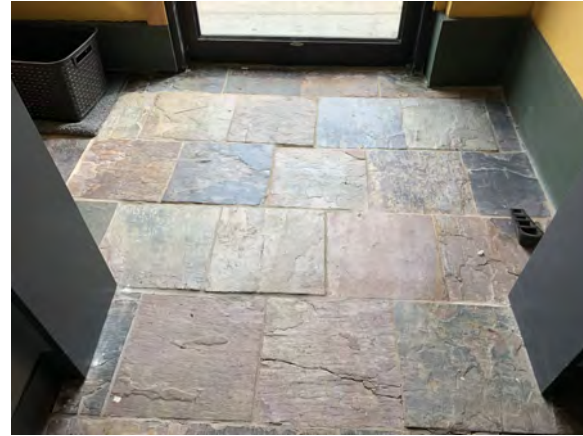
VIEW OF EXISTING VESTIBULE FLOORING AND WALLS TO BE REMOVED.

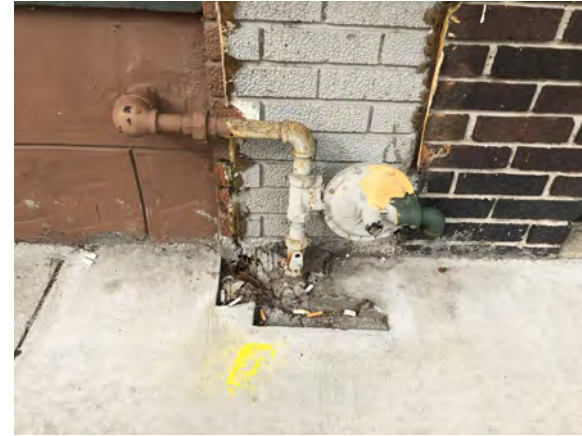
EXISTING GAS REGULATOR EXPOSED DURING INVESTIGATIVE DEMOLITION. SIDEWALK TO BE REPLACED.

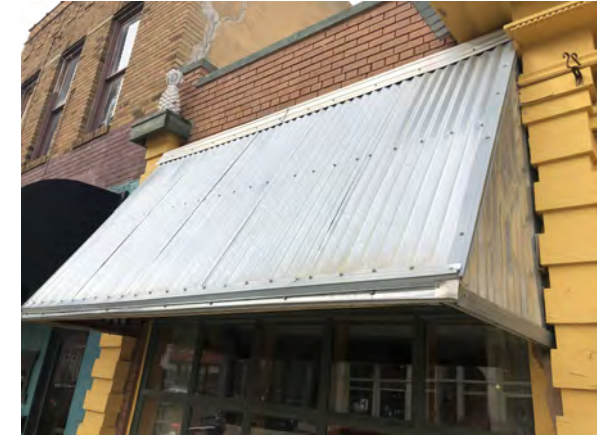
EXISTING CORRUGATED METAL AWNING AND WOOD CLADDING TO BE REMOVED.

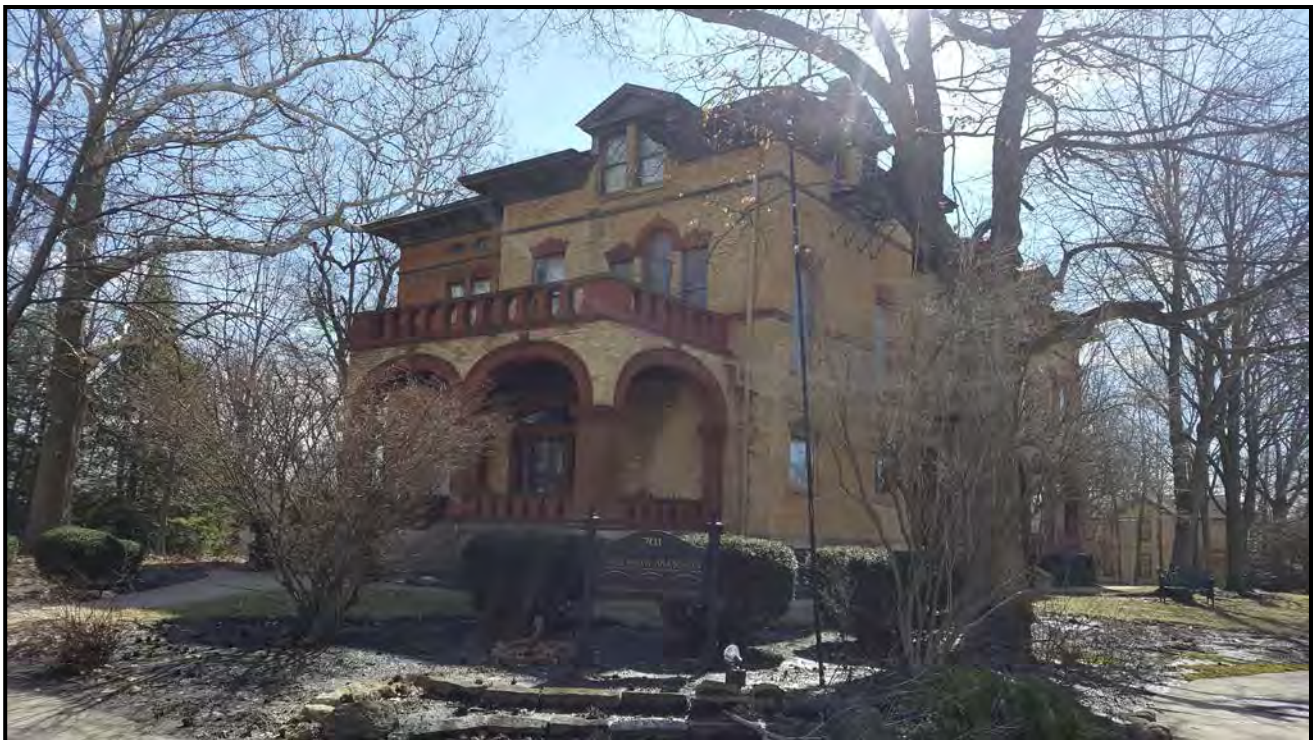
Picture of Subject Property

The site, 701 E. Taylor Street, is located at the corner of Clayton and Taylor Streets. The site is listed on the National Register of Historic Places and has the S-4 Historic District Overlay. The house was designed by G.W Bunting in 1868, and by 1872 the house was sold to Matthew T. Scott, a developer. The house stayed in the Scott-Vrooman family for generations. In 1901, Arthur L. Pillsbury was retained to supervise an extensive remodel, which increased the square footage of the home by 60%. The exterior was altered to a Romanesque influenced style. The house is currently a Bed and Breakfast establishment.

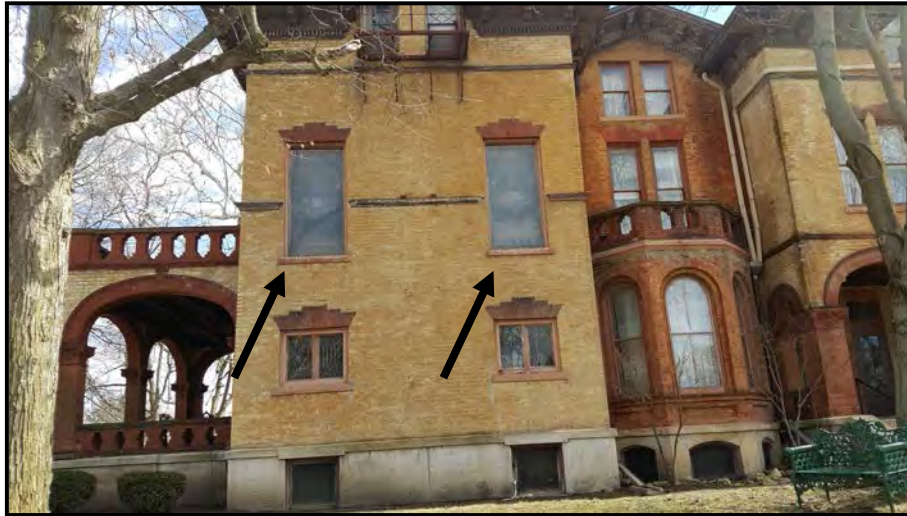
The house contains 8' Tiffany stained glass windows throughout the house. The windows are experiencing some wear and tear causing them to buckle and begin to crack. It is essential for stained glass windows to be restored before cracking begins to be able to fully restore the glass and not have to replace any pieces. The petitioner is proposing to repairs 2 of the 13 windows in the mansion at this time.

The two (2) windows that will be repaired in the project are located on the landing, visible from S. Clayton Street. The project will include removing the windows, weatherproofing, and taking the windows to a work studio for repairs. Based on the scope of work submitted, the restoration will include

making a rubbing of the complete window. The rubbing will have all the pieces of the window numbered so that each piece is replaced in its original position. Once the documentation is complete, the window is disassembled, all the lead is removed and recycled, and the pieces cleaned with water.¹ The restoration to broken glass is done using thin lead patches, and UV stable epoxy adhesive. Restoration is considered top priority, however in the event that the glass must be replaced, a new color match glass will be installed. After the repairs are done, the glass is re-leaded, restoration quality lead is used, and matched to the original size and shape of the panels. The last step before installation would be applying cement between the lead and the glass for water proofing.² The wooden window frames do not appear to have any problems, and according to the scope of work, the frames will be prepped with stain and clear coat. Reinstallation of the panels will be the final step. The petitioner would also like to install a plate glass window on the outside for protection of the stained glass windows.
